INVENTORY FORM FOR STATE HISTORIC SITES SURVEY

Jabez Brown Farm

Church Hill

QA-435

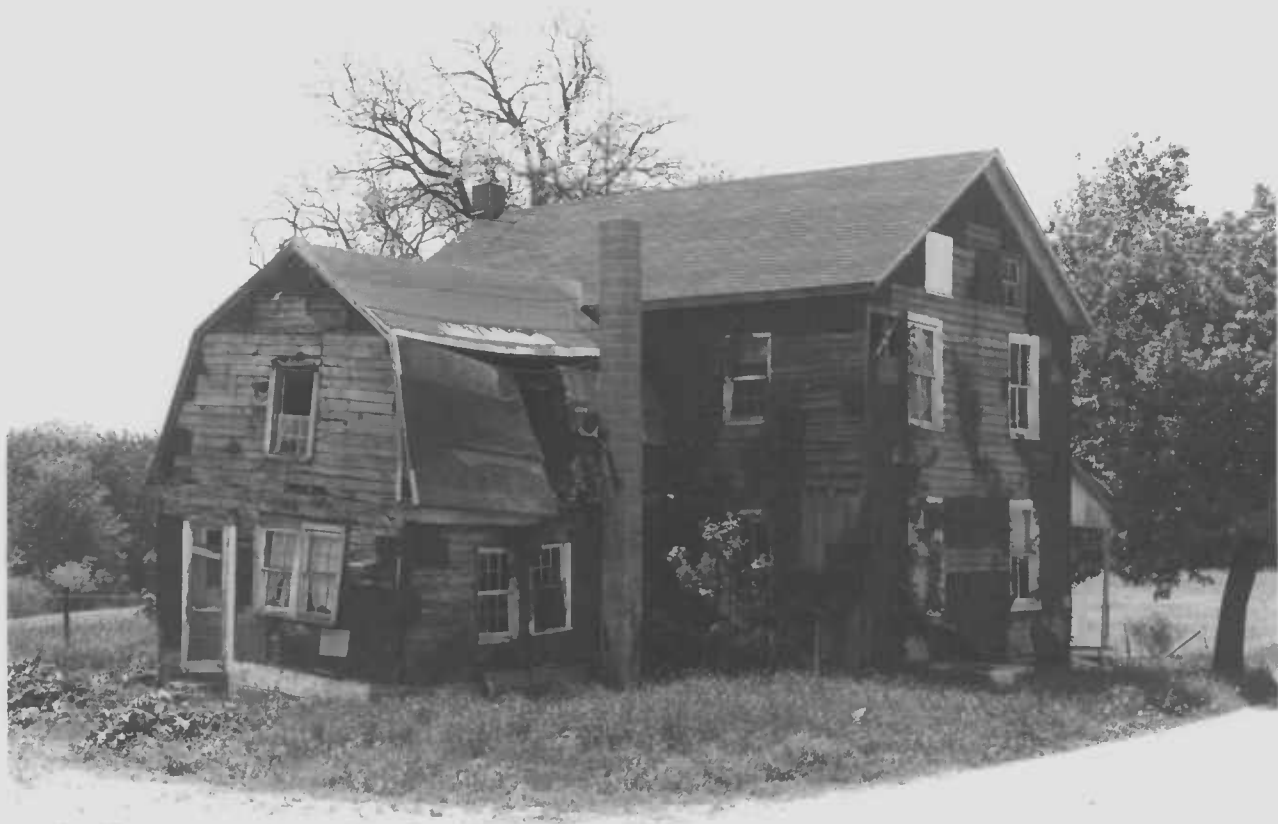
QA-435

On the east gable wall, there is a modern door in the left bay and a pair of 6/6 windows in the center on the first floor and a single 6/6 window centered on the second floor. The window openings are clearly later insertions made when the original gable chimney was demolished. The siding on this wall is laid flush, and seams in the siding near the first floor eaves suggest a porch or a small addition has been removed.

The only openings in the north facade are a pair of 6/6 windows to east of center on the first story and a 6/6 shed roof dormer centered on the second story. The east window on the first story appears to be original,

Jabez Brown Farm
Lieby Road, Church Hill vic.
Orlando Ridout V 1981
Early wing from Northeast

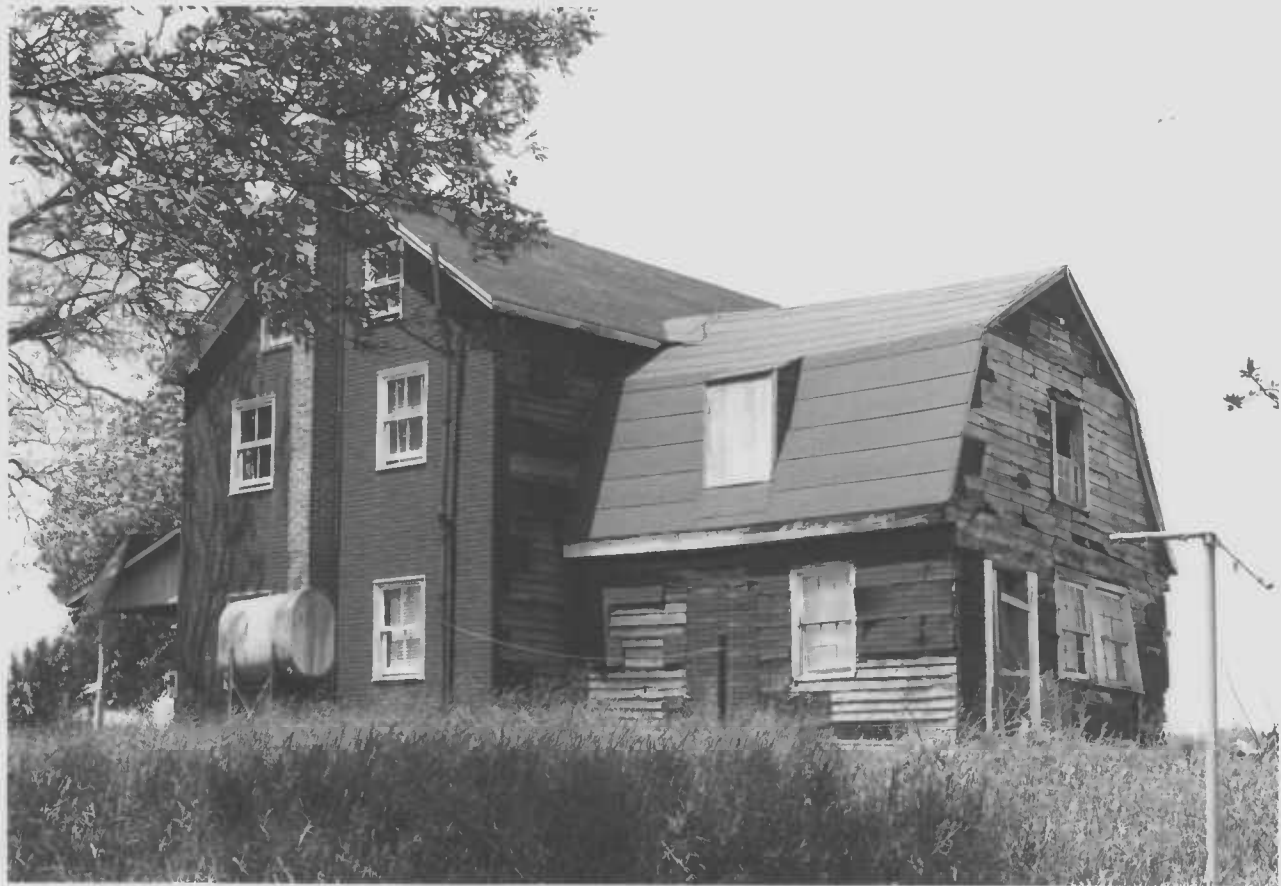
QA-435

The exterior appearance of the gambrel section has been altered considerably over the years. On the south facade there is one 6/6 window on the first story in the east bay and a blocked door opening to the west. A 6/6 shed roof dormer directly above the door has been blocked with plywood. The building rests on a brick and fieldstone foundation and is covered with plain horizontal siding, a plain box cornice and roll asphalt roofing.

Jabez Brown Farm
Lieby Road, Church Hill vic.
Orlando Ridout V 1981
View from Southeast
